Alert service bulletin no. SB02/2016

Subject: Canvas coating of wings, horizontal tail and vertical tail rudder on all types of ZEPHYR aircraft

Date of issue: 1.9.2016

Affected products: ZEPHYR, ZEPHYR 2000 and ATEC 122 Zephyr

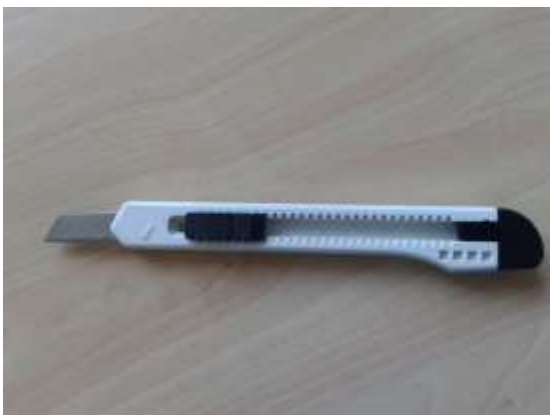
Pic. 1: example of the tool suitable for inspection of coating attachment

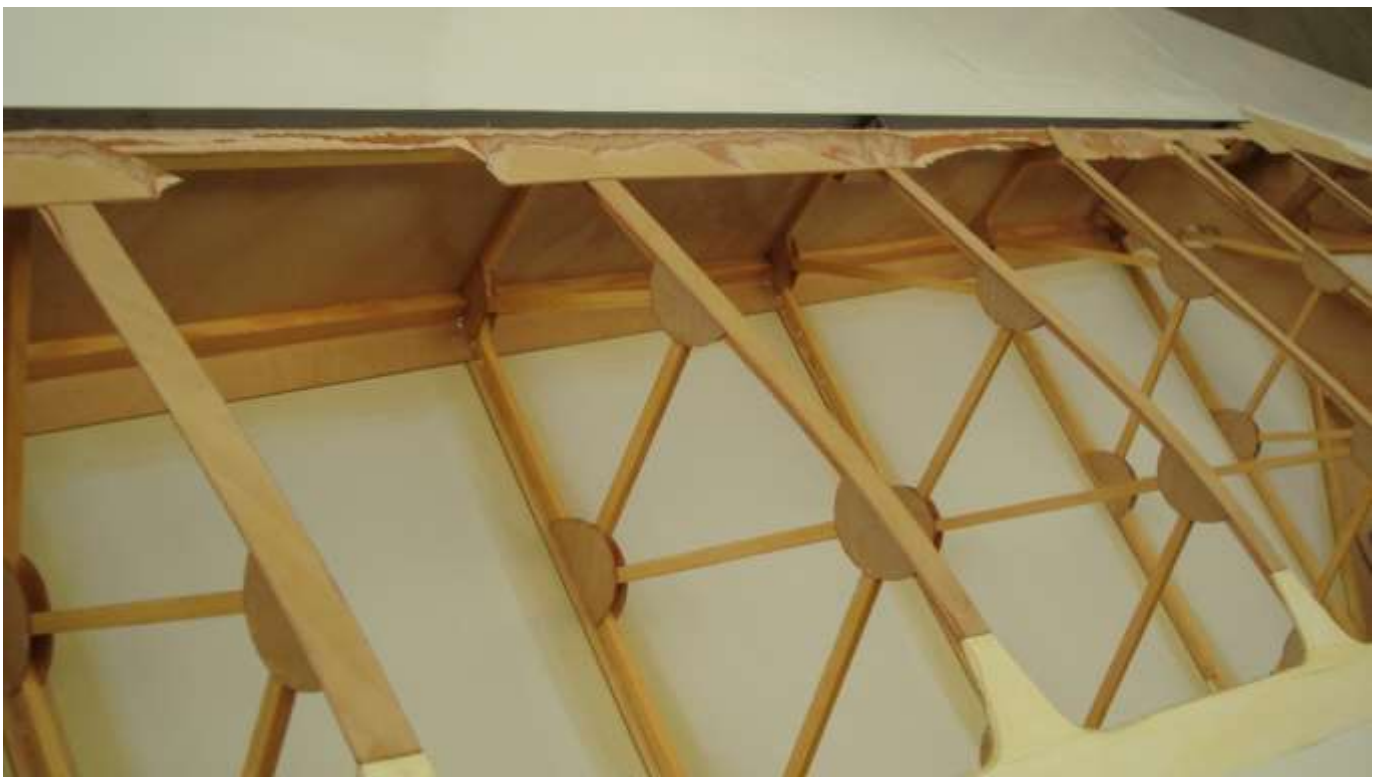
A separation of the fabric coating from the right wing in-flight was observed at ATEC 122 Zephyr airplane. The airplane returned to the airport and safely landed. The incident occurred due to exceeding of the lifetime of the coating which is 10 years since the airplane came into operation as stated by its manufacturer. The material lifetime can be shortened due to poor condition of the fabric bonding caused by extremely unsuitable climatic conditions. Improper adherence of the fabric coating is indicated by slight lifting or detachment of the fabric on bonded edges or identified by easy intrusion of an applicable sharp thin tool between the fabric coating and inside wing structure. In such case the airplane is considered as not airworthy and it is necessary to make re-coating of all parts of the airplane.

Pic. 2: Fabric coating separated from the upper part of the wing

Check the bonding of the coating on wings and horizontal tail before next flight. There must not be any visible crack between the fabric coating and hard surface of the wing. If even limited detachment of the coating is observed, try to input any sharp tool into that slit and gently pass the tool through it to check its depth. If the tool is able to easily intrude between the coating and wing structure, it is necessary to remove the aircraft from service and to make its complete re-coating. If the tool is not able to intrude into the slit, bond the slit by contact glue to avoid water intrusion between the fabric coating and wing structure and so to avoid further degradation of bonding. We recommend to cover the bonded connection situated on torsion box of the wing and horizontal tail by white plastic tape of 25mm width. The tape shall be placed in a position to cover the connection of torsion box and coating by its middle part.

Check the bonding condition same way as described by the par. 1. Then, cover the connection on the torsion box of the wing and horizontal tail by white plastic tape. Ask the aircraft producer or its authorized workshop for re-coating.

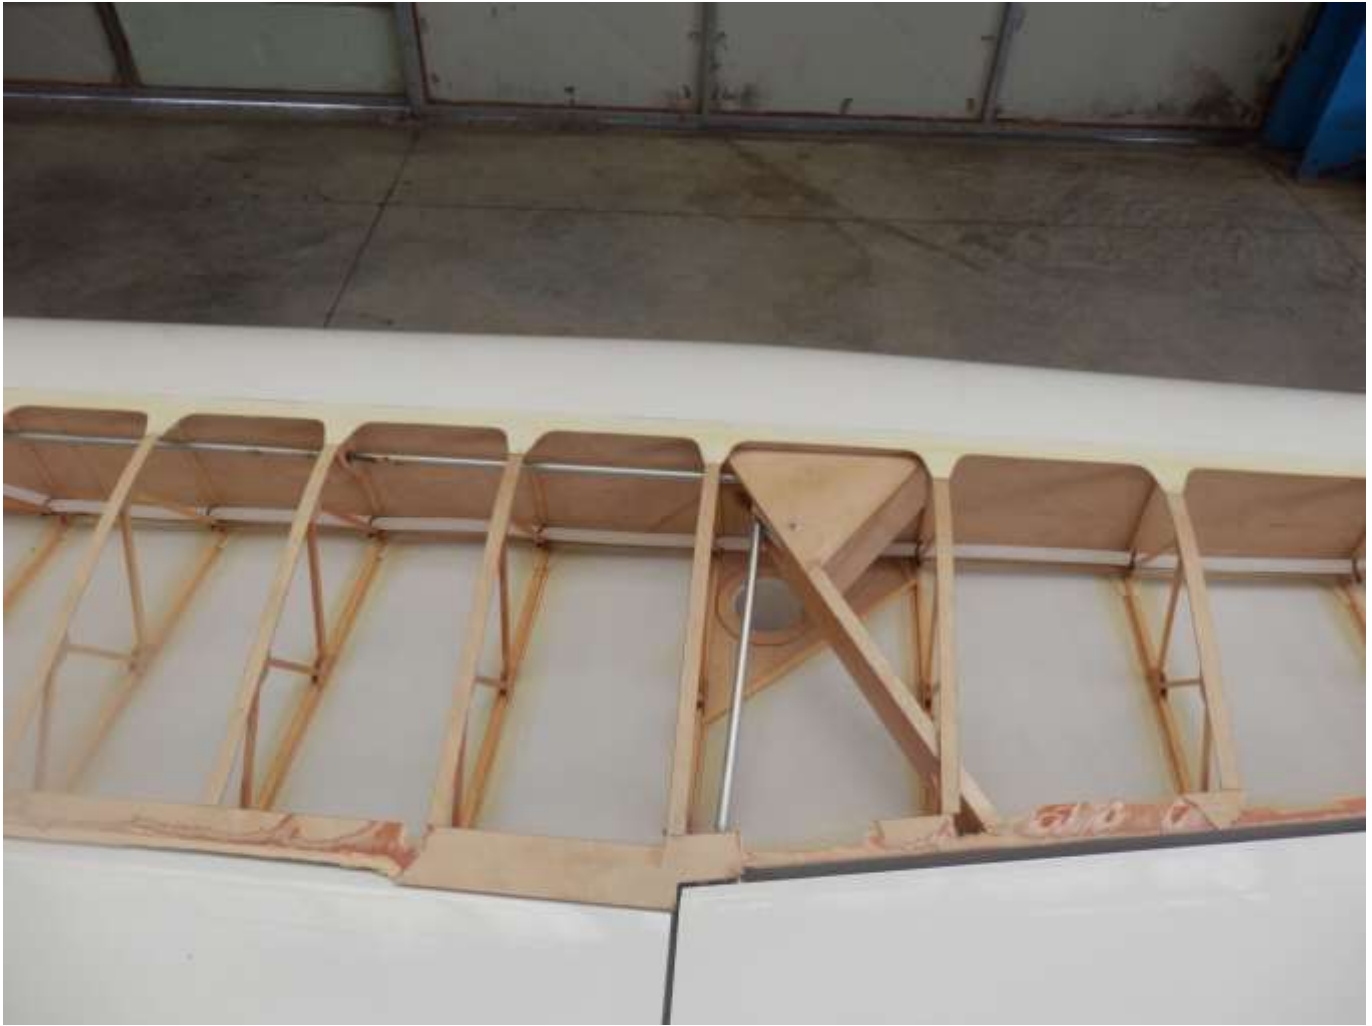
Pic. 3: Fabric coating separated from the upper part of the right wing

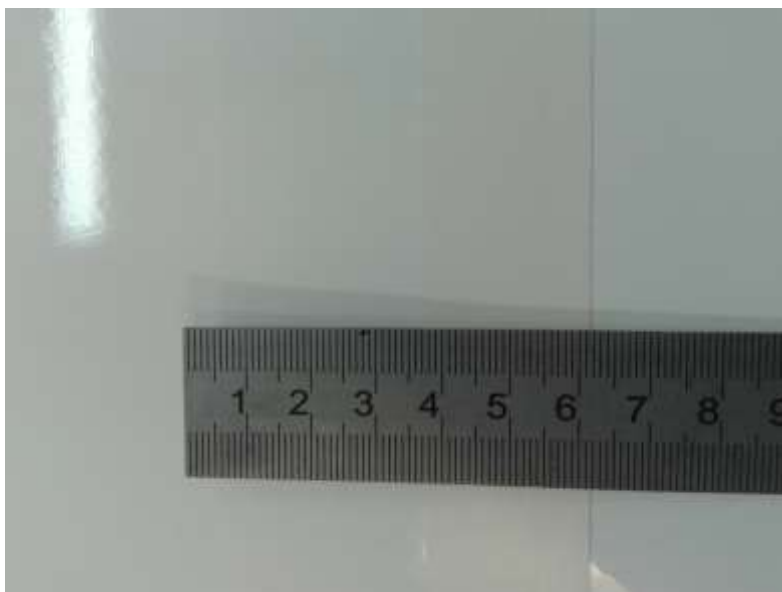
Pic. 4: Detail of the tape covering bonded connection of the coating on torsion box

3. The producer extended the width of bonded connection on torsion box of the wing. The original width of 35mm is now extended up to 50mm. The connection is covered by white plastic tape.

We recommend to cover all bonded connections situated on torsion box of wings and horizontal tail by white plastic tape of 25mm width. The tape shall be placed in a position to cover the connection of torsion box and coating by its middle part.
