Mandatory service bulletin no. SB01/2016

Subject: Inspection of the airbox at ATEC 122 Zephyr and ATEC 321 Faeta ultralight aircraft

Affected products: ATEC 122 Zephyr and ATEC 321 Faeta aircraft equipped with unoriginal airbox

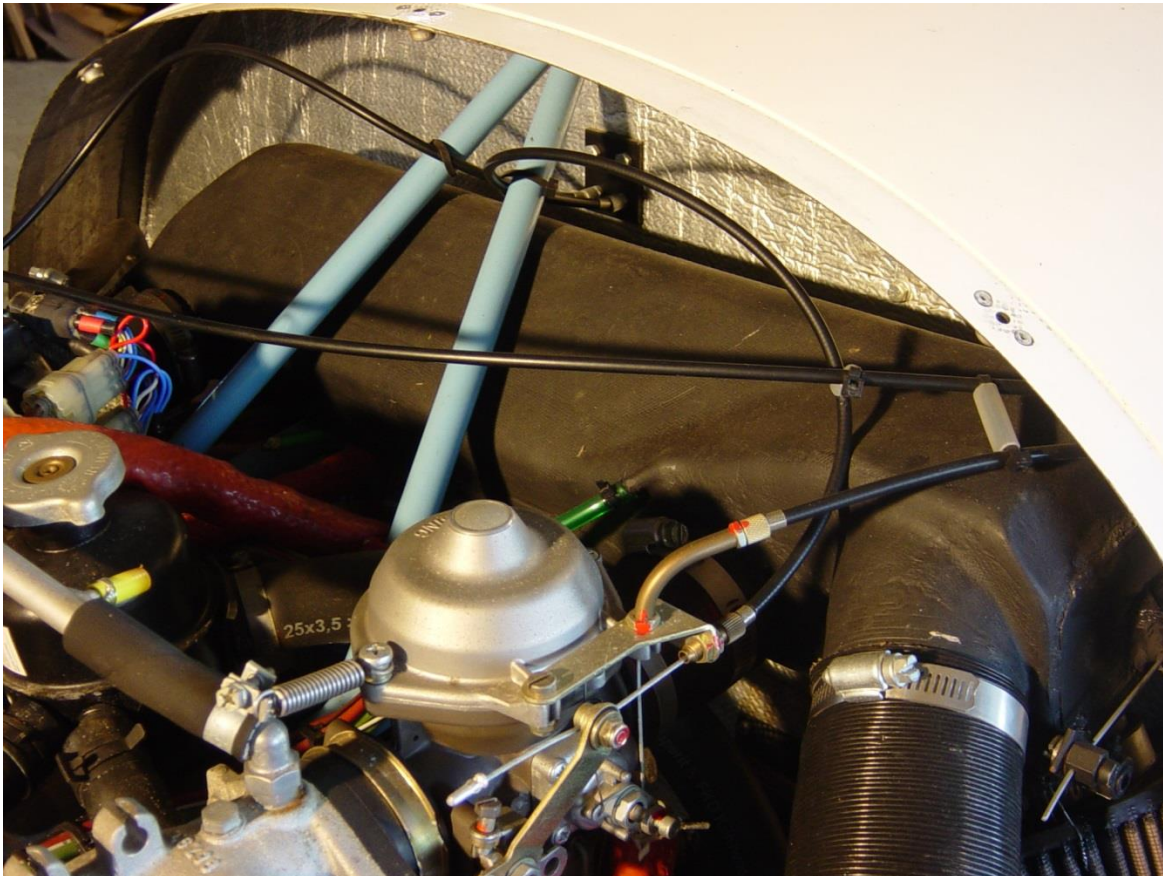
Pay special attention to the hot air hose from the exhaust system to the Airbox. There are evidences that the hot air hose is equipped with an air filter inside. The air filter is attached by thin wires. Pay attention to see if you find wires or signs of holes through the hose. This is an incorrect attachment of the air filter, which may release and the air filter or its assembly may be sucked into the airbox or carburettor and causes the engine failure.

The airbox assembly on the above picture is **not the Atec product and Atec does not recommend its use.** The use of such unoriginal airbox assembly in combination with an airfilter assembly within the hot air hose, may cause the engine failure during the flight.

Remove the hot air hose to find out if there is an air filter assembly installed inside. Such air filter is not visible until the hose is dismounted. Check the filter's assembly position and integrity and remove it out of the system immediately.

The Atec further recommends to completely remove the airbox assembly and to install the air filters directly on carburettors or to replace the airbox with original Atec product.

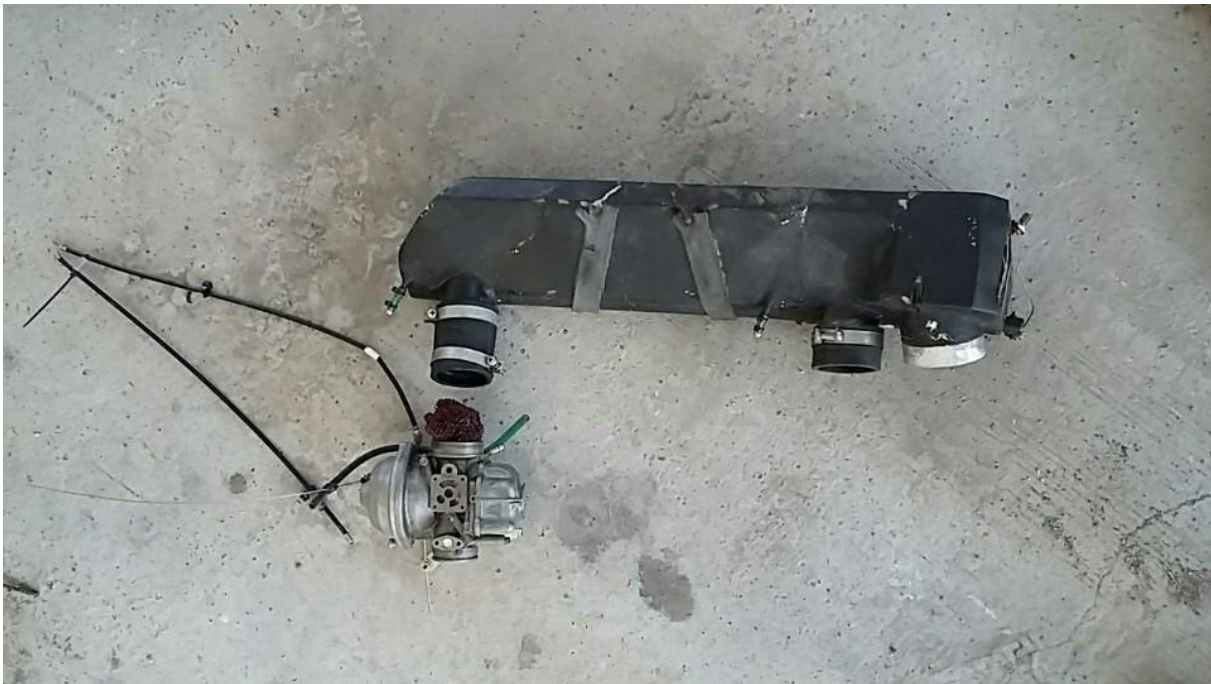
The airbox with the air filter assembly which was sucked inside

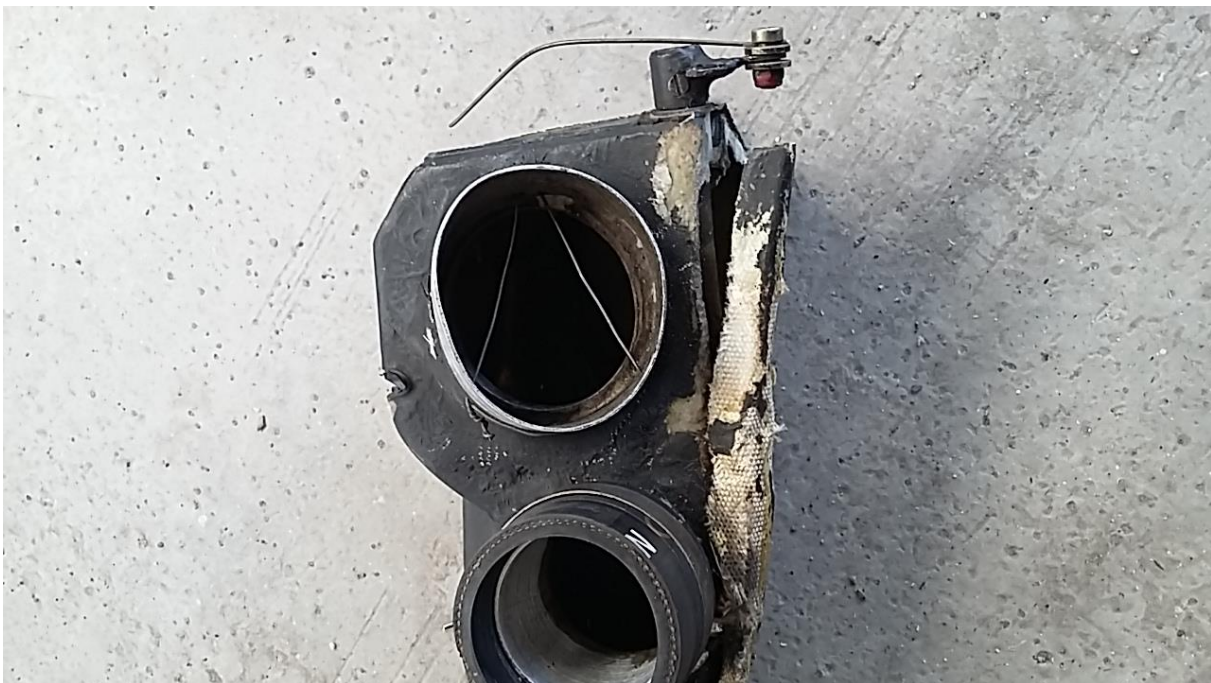
The wires which hold the air filter inside the hose during the operation
