Alert service bulletin no. SB02/2016

Subject: Canvas coating of wings, horizontal tail and vertical tail rudder on all types of ZEPHYR aircraft

Date of issue: 1.9.2016

Affected products: ZEPHYR, ZEPHYR 2000 and ATEC 122 Zephyr

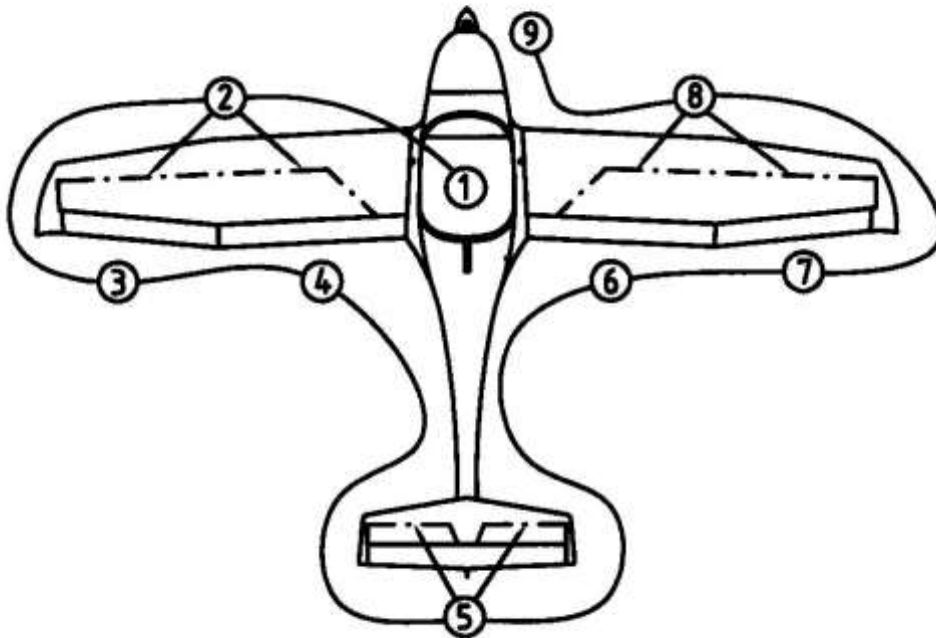
- 1/ Cockpit – switches, seat belts, instruments, seats, controls, canopy locks, canopy condition check
- 2/ Left wing – coating and fabric bonding condition*, play, Pitot tube

- 3/ Left aileron – coating and fabric bonding condition*, free movement, attachments, controls
- 4/ Left flap – coating and fabric bonding condition*, attachments, controls, play
Left main gear leg – condition, brake fluid leak, wheel spat

- 5/ Tail – surface condition, coating and fabric bonding condition*
VT – surface, attachments, control
HT – coating, attachments, fitting covers
Rudder – surface, attachments, control

- 6/ Right flap - coating and fabric bonding condition*, attachments, controls, play
Right main gear leg - condition, brake fluid leak, wheel spat
- 7/ Right aileron - coating and fabric bonding condition*, free movement, attachments, controls

- 8/ Right wing – coating and fabric bonding condition*, play
- 9/ Nose wheel – condition, play, wheel
Engine – operation liquids amount, engine cowling
Propeller – condition, spinner tightness

* for detailed instructions see Art. 8, Par. 8.1., 8.1.1. and 8.1.2.

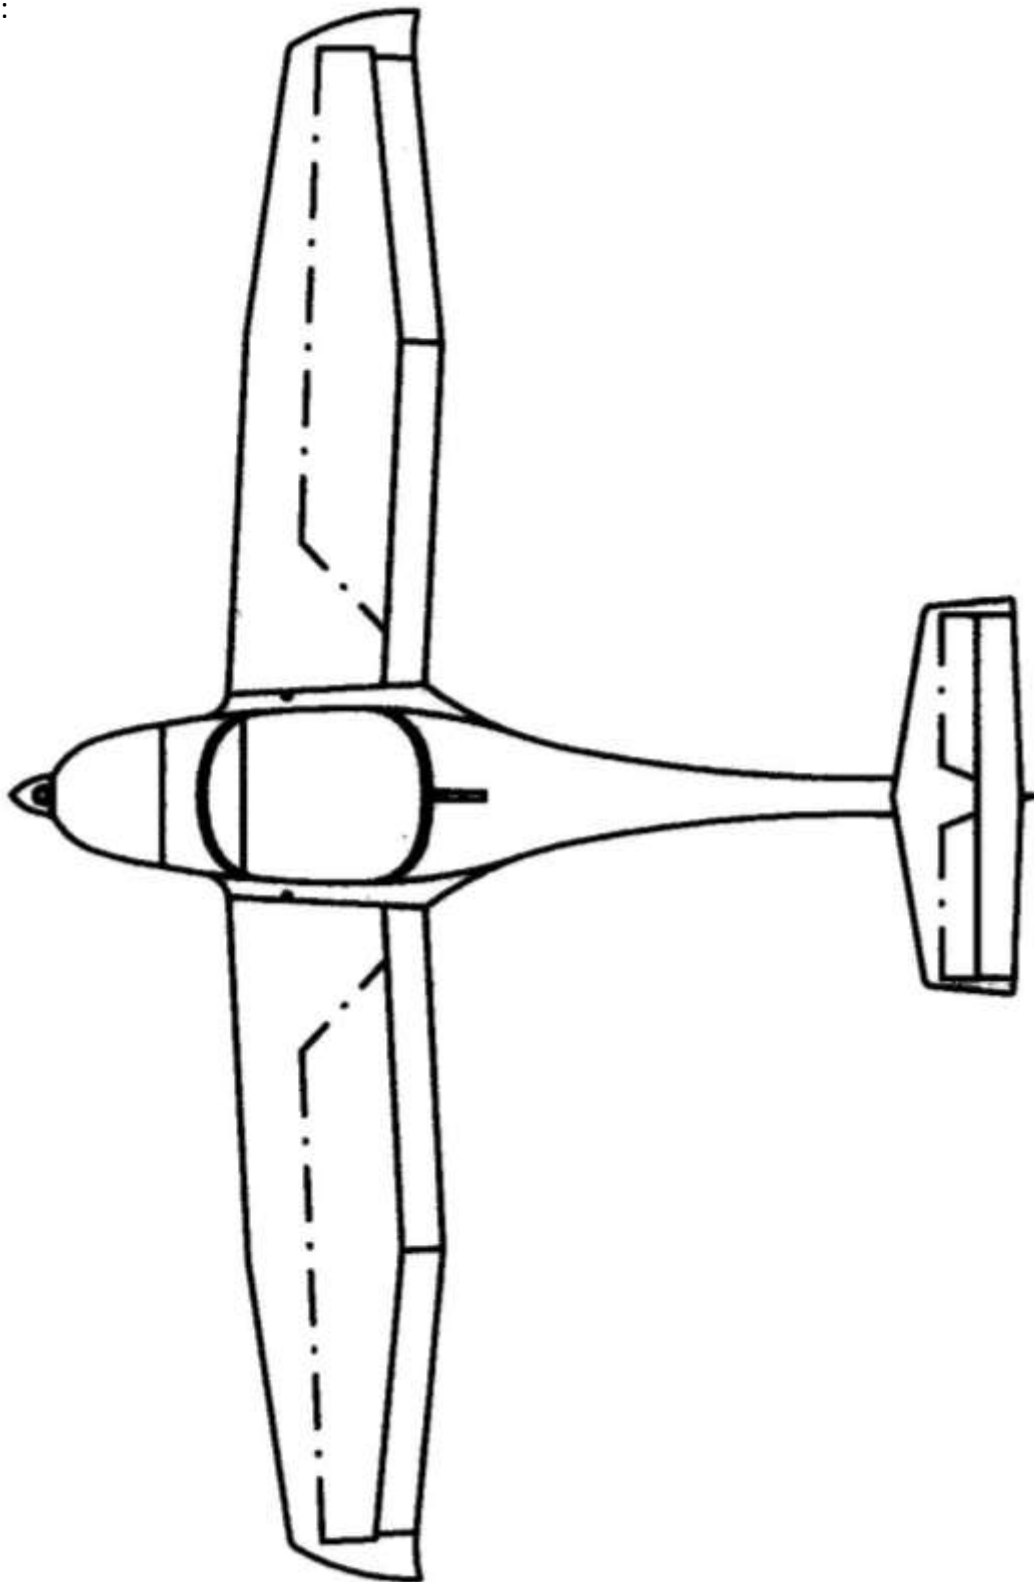
View from above:

There can not be any visible crack between the fabric coating and hard surface of the wings/ elevator/rudder. If even limited detachment of the coating is observed, try to input any sharp tool (e.g. knife) into that slit and gently pass the tool through it to check its depth. If the tool is able to easily intrude between the coating and wing structure, it is necessary to remove the aircraft from operation and to make its complete re-coating. If the tool is not able to intrude into the slit, bond the slit by contact glue to avoid water intrusion between the fabric coating and wing structure and so to avoid further degradation of bonding.

We recommend to cover all bonded connections situated on torsion box of wings and horizontal tail by white plastic tape of 25mm width. The tape shall be placed in a position to cover the connection of torsion box and coating by its middle part.
